MERCEDES 722.3 AND 722.4

MERCEDES 722.3, 722.4

Mercedes first introduced the "722" models in model year 1980. The 722.3 is found in most models and the 722.4 is found in the 190 vehicles. This manual covers the procedures necessary to overhaul and repair both of these units. This manual also covers the differences between the units in the valve body and governor. The basic internal components such as the pump, gearsets, drums clutches and bands are the same. This manual includes both the original manufacturers information along with some of the engineering changes and updates.

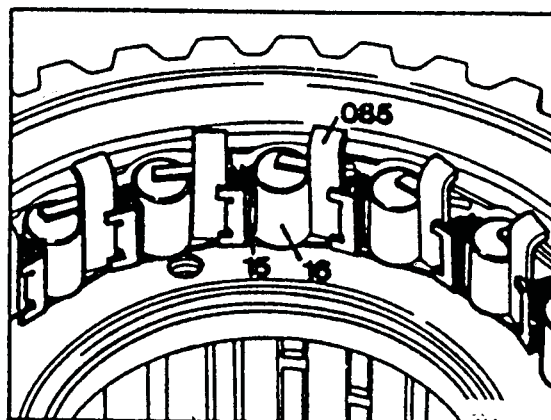
Insert inner race of one way roller clutch (13) while turning counter -clockwise, then remove retaining plates (085).

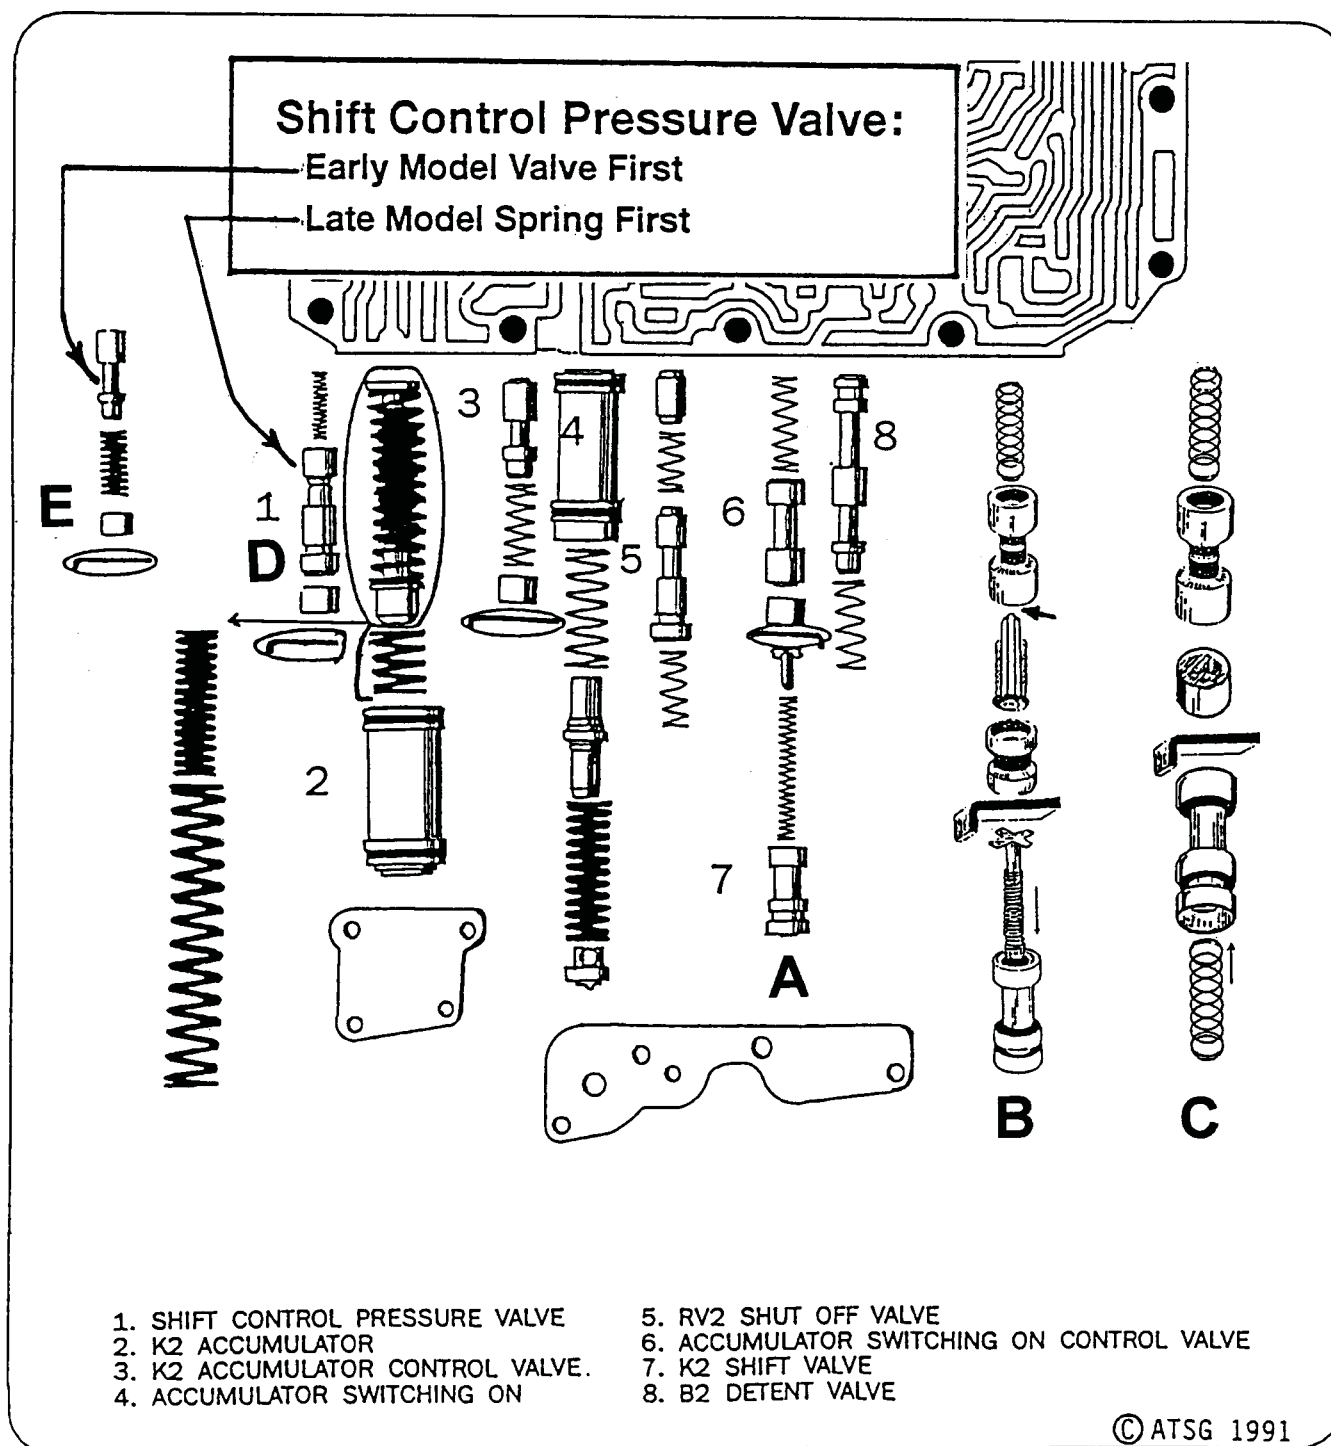
The "D" and "E" shift control pressure valves can be found to be installed valve first then spring (early) or spring then valve (late). Be sure to check valve type and line-up.
